Errata: CS4270 Rev B0 Silicon

Reference CS4270 Data sheet DS686A1

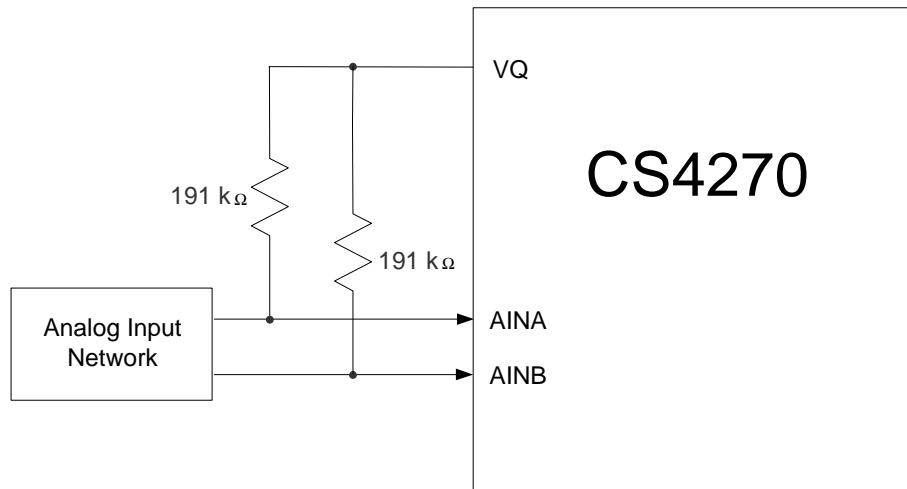
- ◆ The common mode voltage at pins AINA and AINB rises over time after power up unless the pins are forced to the proper level by a 200 kΩ pull-up to the VQ pin where VQ = 2.5 V for VA = 5 V or VQ = 1.65 V for VA = 3.3 V. If the common mode voltage is not forced to VQ via a pull-up, the result will be clipping, increased distortion and degraded performance as seen at the A/D output.
